Dynamic monitoring of concrete structures using fibre optic sensing cables

Monitor Optics Systems (MOS) distributed strain and temperature sensing cables based on optical sensing technology, have been installed within concrete beams to demonstrate the resolution and range of the sensors with the view to using them on large scale concrete structures that require continuous monitoring.

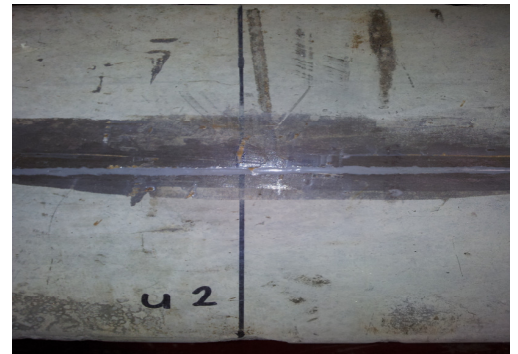
1mm cable embedded in 5x5mm groove

The sensor selected for this application was a standard 1mm diameter fibre glass sensing cable which can have large numbers (up to 40) of distributed sensors (Fibre Bragg Gratings-FBG's) on a single cable. The sensing cable was embedded into a 3mmx5mm groove in the beam using epoxy resin as shown below. A flat profile cable can also be adhered to the surface of a structure.

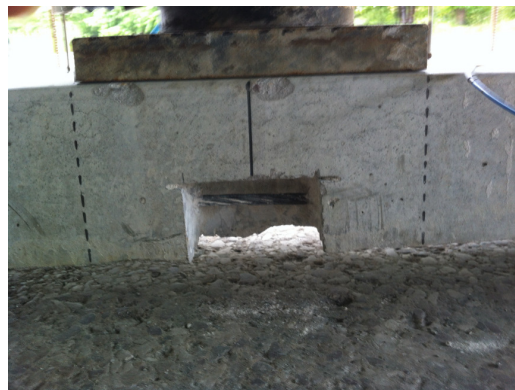
Exposed reinforcement bar to be cut

The aim of the tests was to prove that MOS FBG sensing cables are able to monitor a pre-stressed beam and detect failure of a reinforcing element within the beam. This was demonstrated by loading the beam using a hydraulic jack and pressure cell and monitoring the strain changes within the beam during this process. Whilst under load a reinforcement bar was cut so it could be seen that the sensors could detect the changes in strain within the beam during a failure scenario in real time.

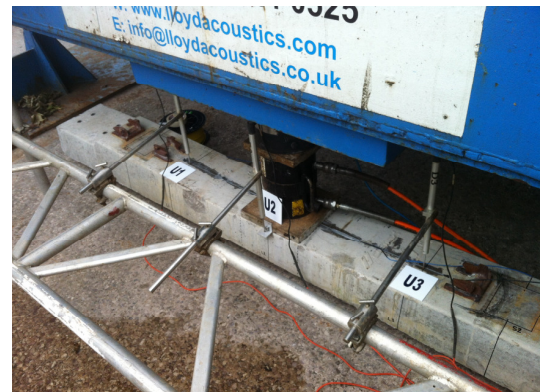
Instrumented beam and test rig

A total of two strain cables each containing three FBG sensors were installed in the beam with the sensors at equal spacing's along the beam. One cable was installed in the upper surface of the beam whilst the other in the lower surface, so compression and tension could both be measured. One MOS temperature sensor was also used to provide temperature compensation to the strain sensors.

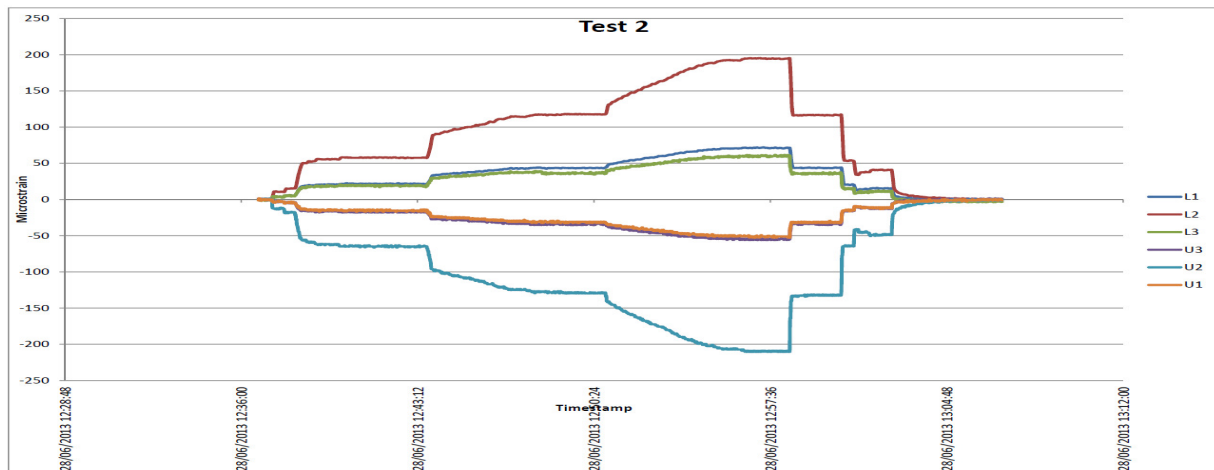
During the test a good relationship between applied load and measured strain was observed. The FBG sensors recorded a reduction in strain on the upper surface of the sleeper and an increase in strain on the lower surface.

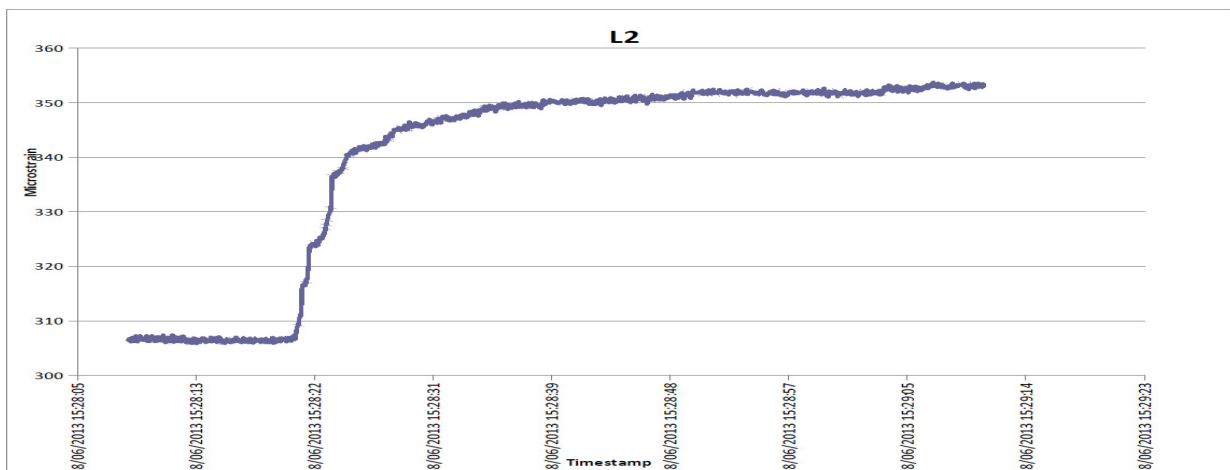
The above graph shows the dynamic response (100Hz) of the nearest sensor before, during and after the cutting of the reinforcement

Data was acquired at 100 Hz (100 times per second) for the dynamic events. Analysis of the strain variations would allow an asset manager to understand the 'structural health' of the asset, assisting with inspection regimes, pro-active maintenance and asset life management.
